Manhole Inspection Summary

Manhole # S51EE_006MH

Record Plat: **51EE** Node: **006** Status: **Found**

Insp Date: **6/27/08 9:11 AM**

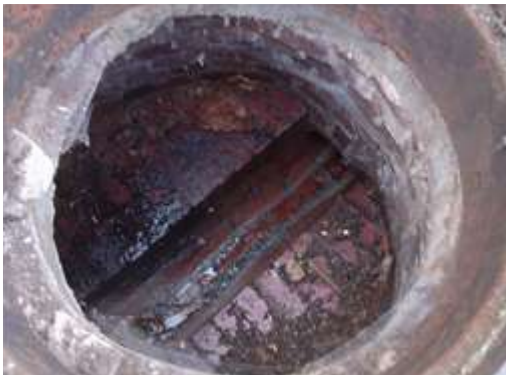
Defect 2

Infiltration: ☐ None ☐ Joint ☐ Cracks ☐ Mortar ☐ Roots ☒ **Wall**

infiltration

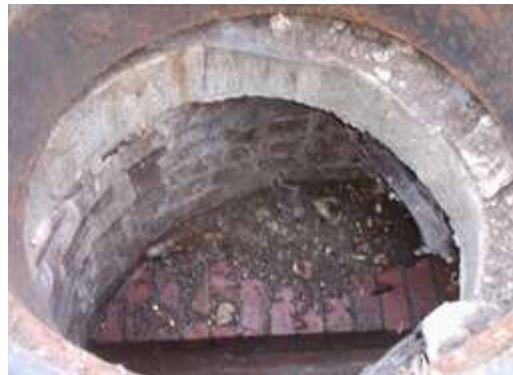
Defect 1

Frame Offset: **2** (in.) Condition: ☒ Sound ☐ Cracked ☐ Leaks

offset frame

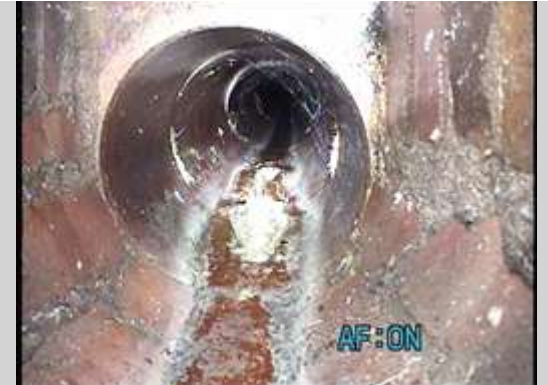
12 O'Clock Outflow

8 in. Circular Gravity Sewer
Pipe Out @ 12 O'Clock

Pipe Height: **8.4** (in.) Rod and Bar (Angled)
Pipe Material: **Clay** ☐ Pipe Lined
Invert Depth: **4.20** (ft.) Flow Characteristics: **Fast**
Deposits: ☒ None ☐ Mud ☐ Sludge ☐ Debris ☐ Grease
Silt Depth: (in.) Deposits Extent:
Infiltration: **None** Pipe Seal Cond: **Sound**

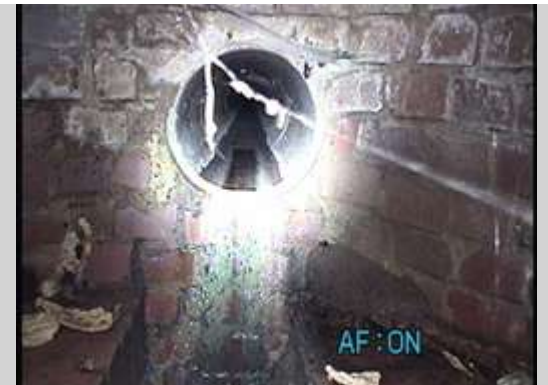
6 O'Clock Inflow

6 in. Circular Gravity Sewer
Pipe In @ 6 O'Clock

Pipe Height: **6** (in.) Rod and Bar (Angled)
Pipe Material: **Clay** ☐ Pipe Lined
Invert Depth: **2.85** (ft.) Flow Characteristics: **Fast**
Deposits: ☒ None ☐ Mud ☐ Sludge ☐ Debris ☐ Grease
Silt Depth: (in.) Deposits Extent:
Infiltration: **None** Pipe Seal Cond: **Sound**
